MONUMENT RECORD

Corner ID: **CICr_G01**

North 1/4 Corner

Section 05- T07N-R01W, 2nd P.M.

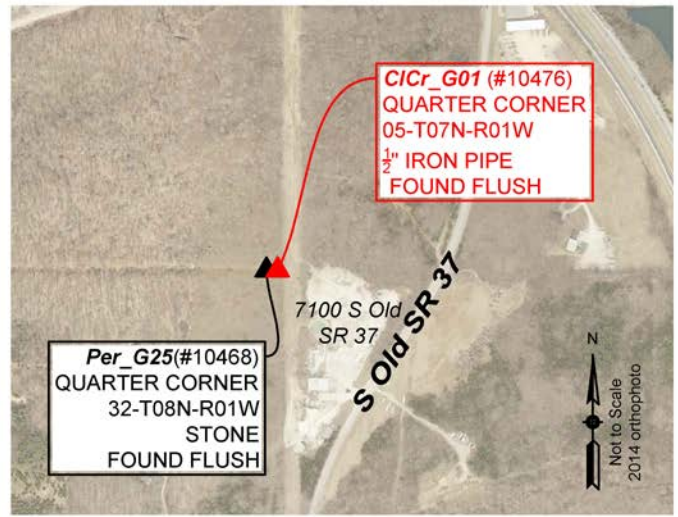
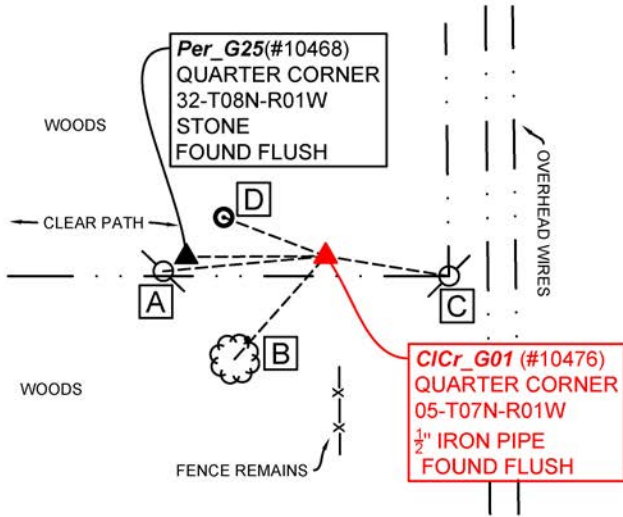
MONUMENT: Describe monument set or found (Include material type, scribing, distance above/below grade, dimensions.)
1/2" iron pipe found with broken yellow plastic cap stamped "PRALL LS1023"

Took new ties. Spray painted orange. A t-post was set 0.25' north of the monument 2.8' above grade facing south

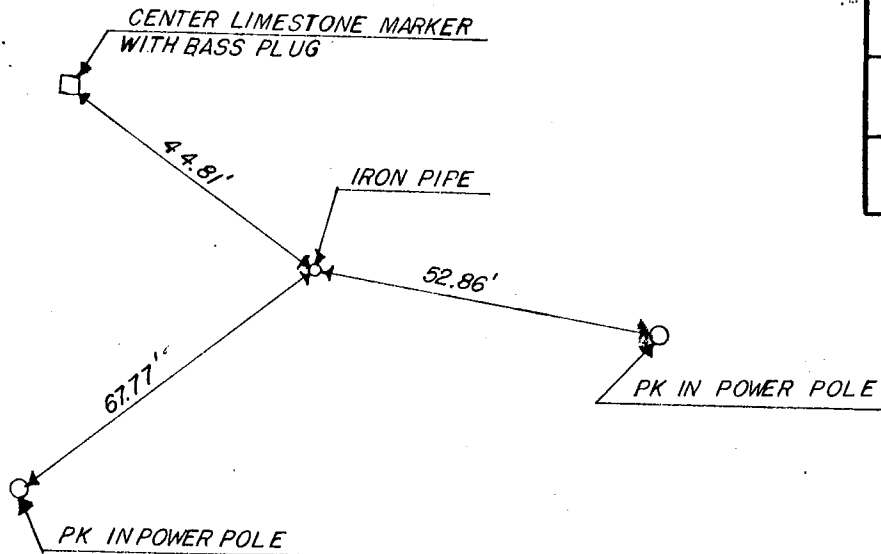
RECOVERY TIE DRAWING

FOUND 1/2" IRON PIPE WITH YELLOW PLASTIC PLUG

1/2" I. PIPE w/
Type Monument YELLOW PLAS. PLUG (END)
Depth FLUSH w/ GRD.
By S.P. #3 & R.I. WILLIAMS
Date DEC. 7, 1987
